Photo Report of Koteles Garage

Site Inspection Date: 06/10/2020

Inspector: Nathan Marcus, E.I.T.

Prepared for: Levandosky v. Koteles Dispute

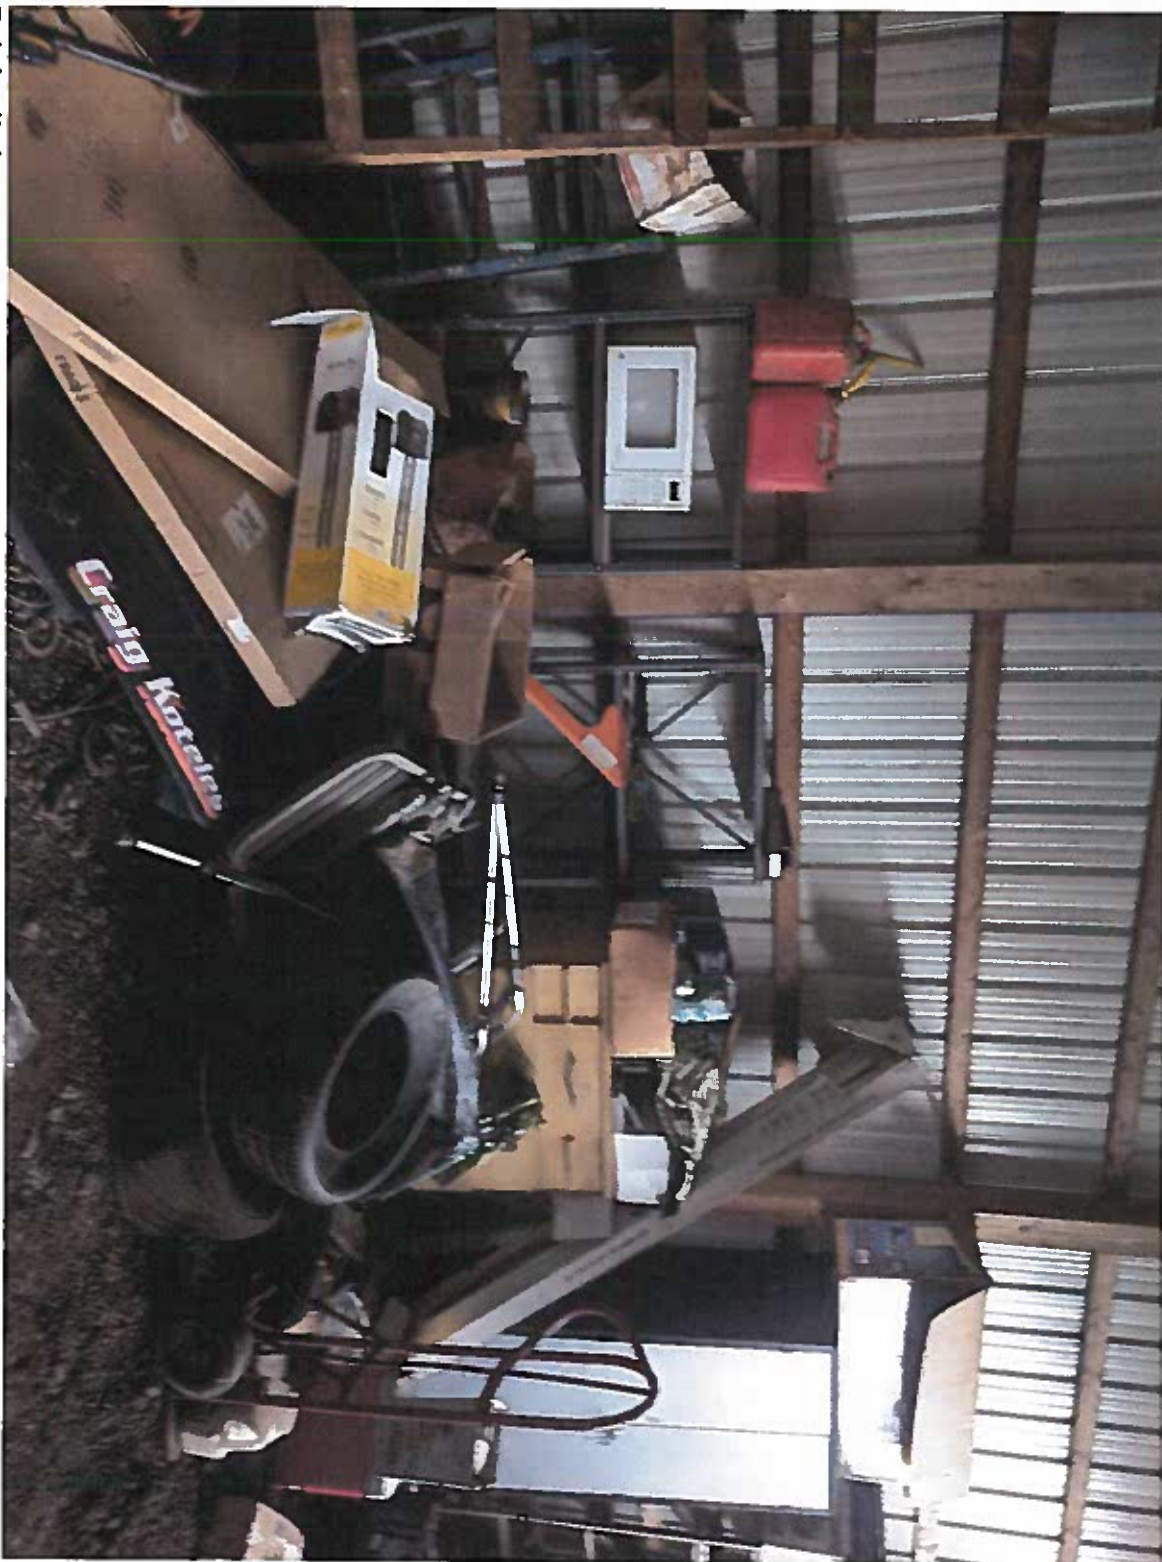
Debris pile in rear garage

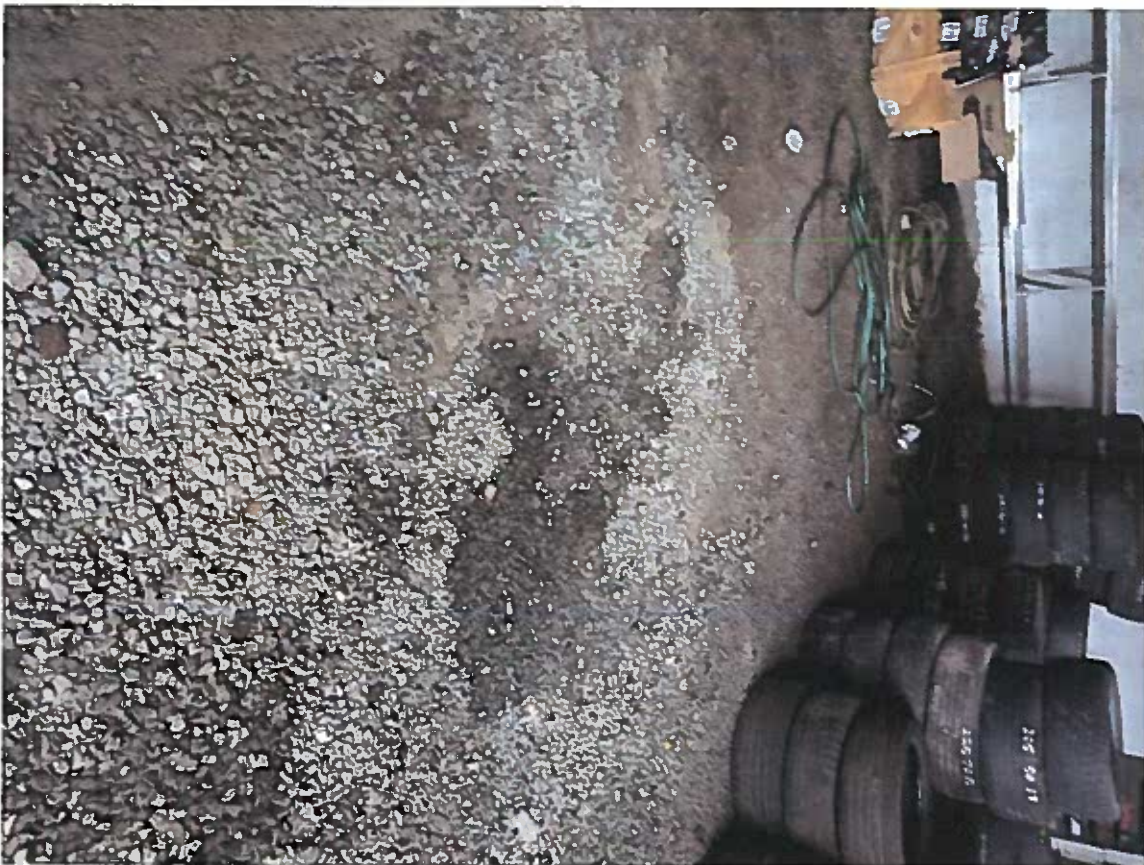
Oil spill on gravel in rear garage.

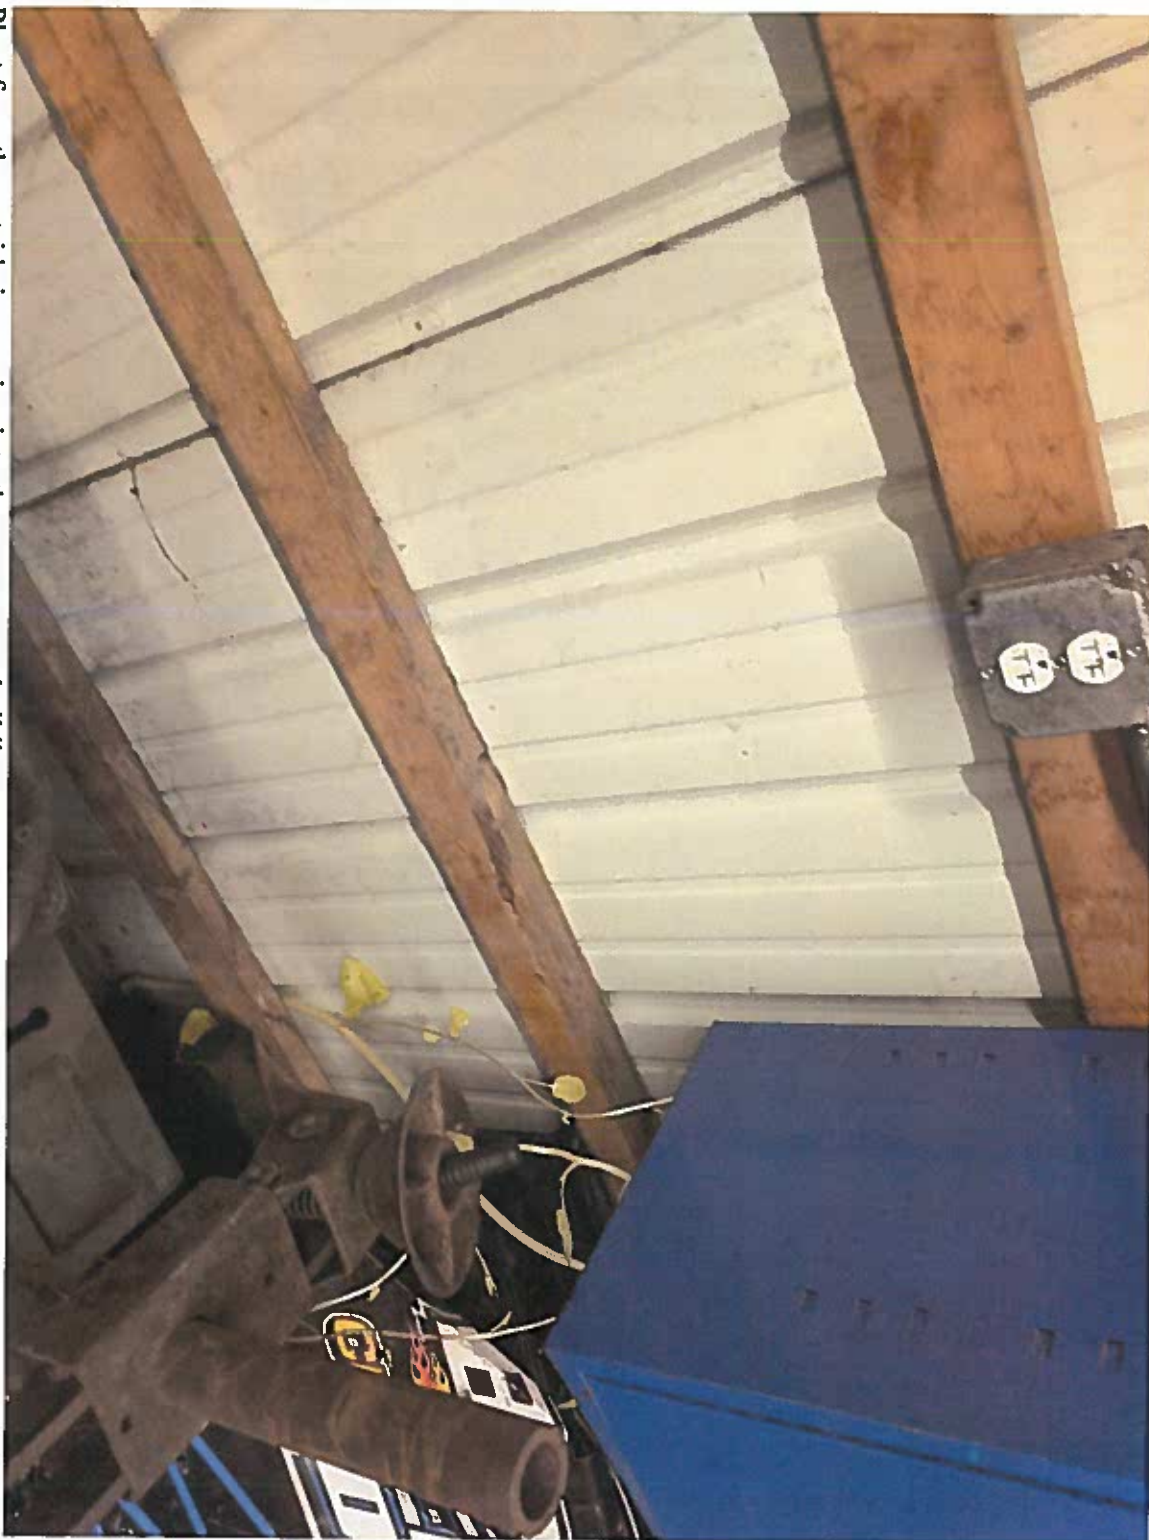
Plant from the outside is growing into the rear storage building.

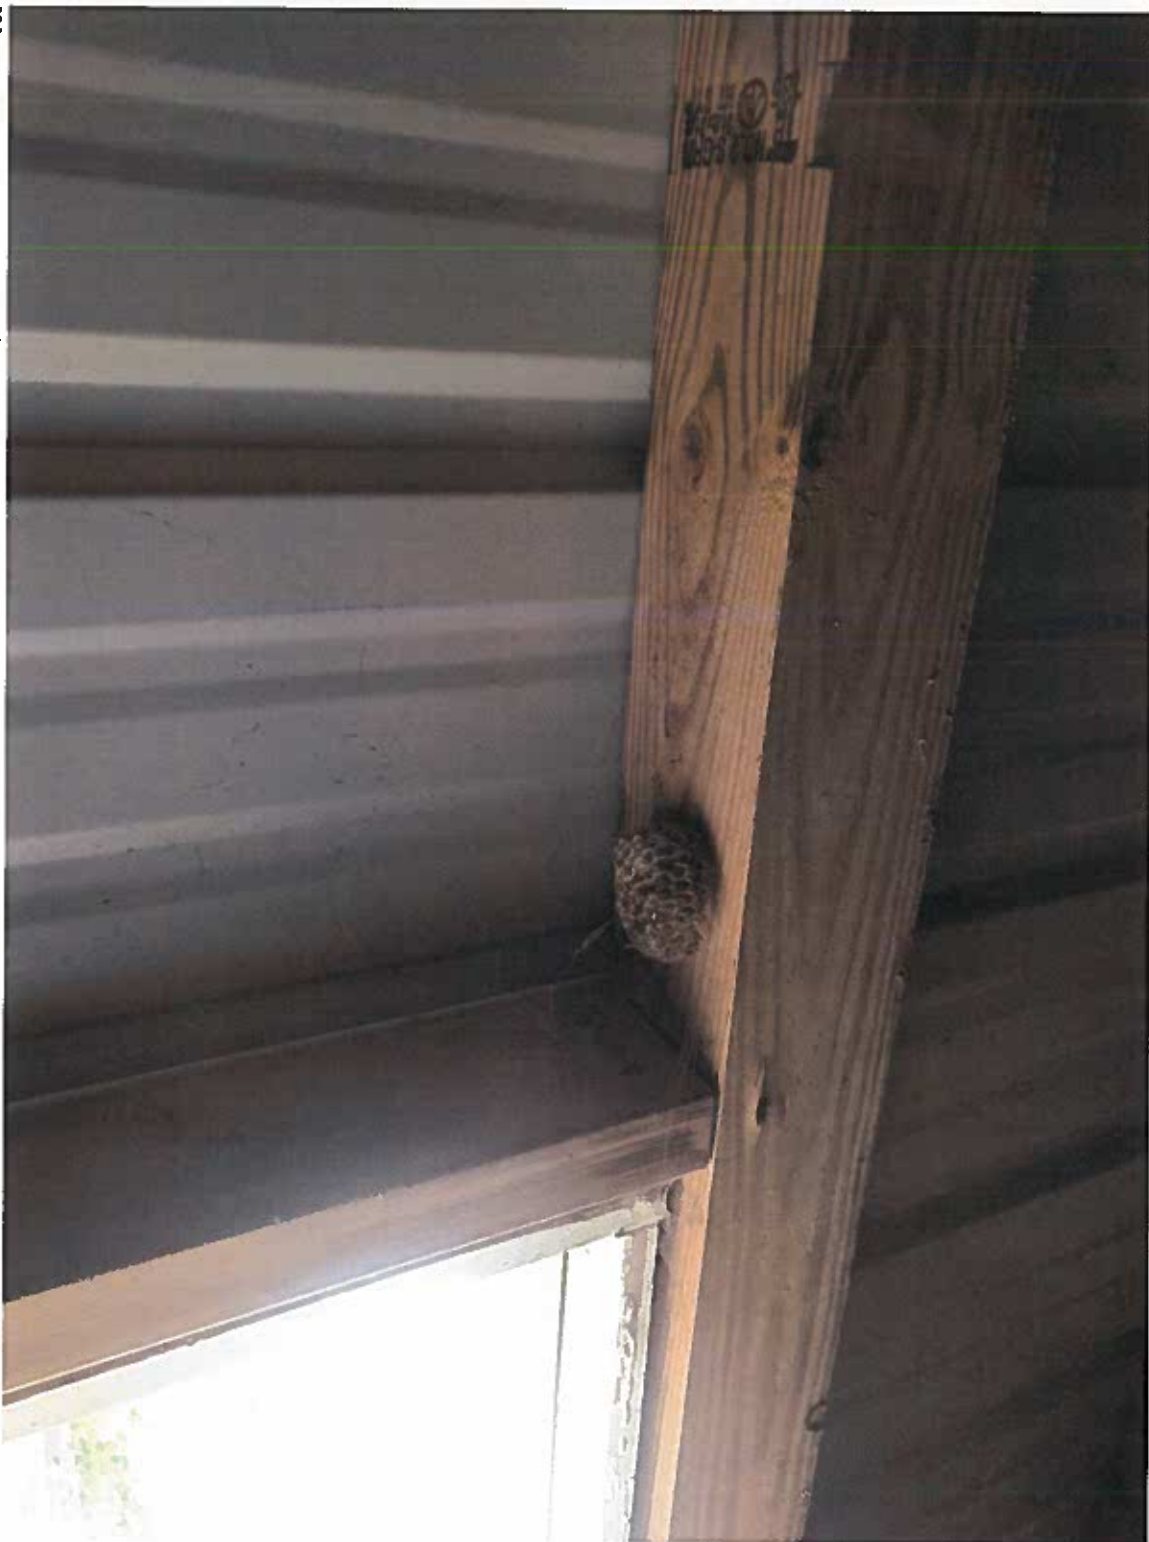
Wasp nest near rear entry door.
